**INTEGRATED PROPULSION CONTROL SYSTEM (IPCS)  
FINAL REPORT  
VOLUME III  
FLIGHT TEST REPORT**

**BOEING AEROSPACE COMPANY  
P.O. BOX 3999  
SEATTLE, WA. 98124**

**AUGUST 1976**

**TECHNICAL REPORT AFAPL-TR-76-61 VOLUME III  
FINAL REPORT FOR PERIOD 1 MARCH 1973 - 30 AUGUST 1976**

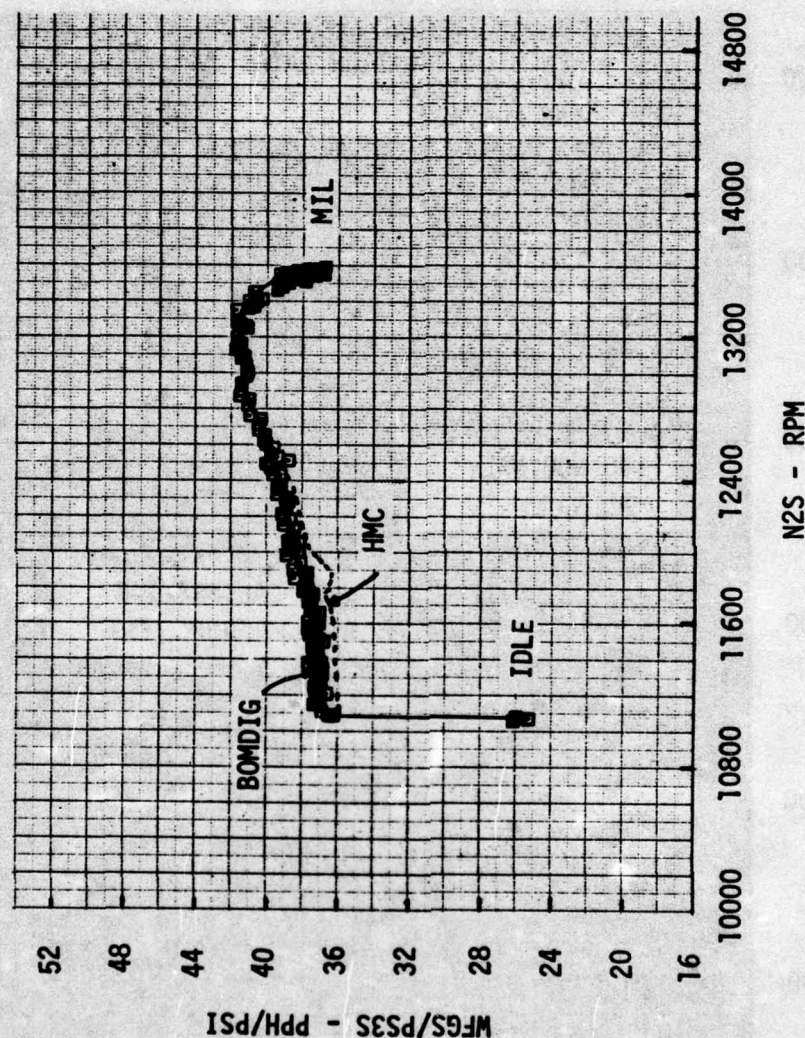
Figure 5.4-23 Idle-M11 Wf/Pb Plot, BOMDIG, HMC

part of the acceleration and line on line at the higher level. The acceleration times from idle to 95% N2 of 11.0 sec for HMC and 10.0 for BOMDIG indicate that the fuel flow delivered to the engine is approximately equal for both modes. As shown in Figure 6.2-44 the HMC and BOMDIG idle to mil accel times are comparable for a number of flight conditions.

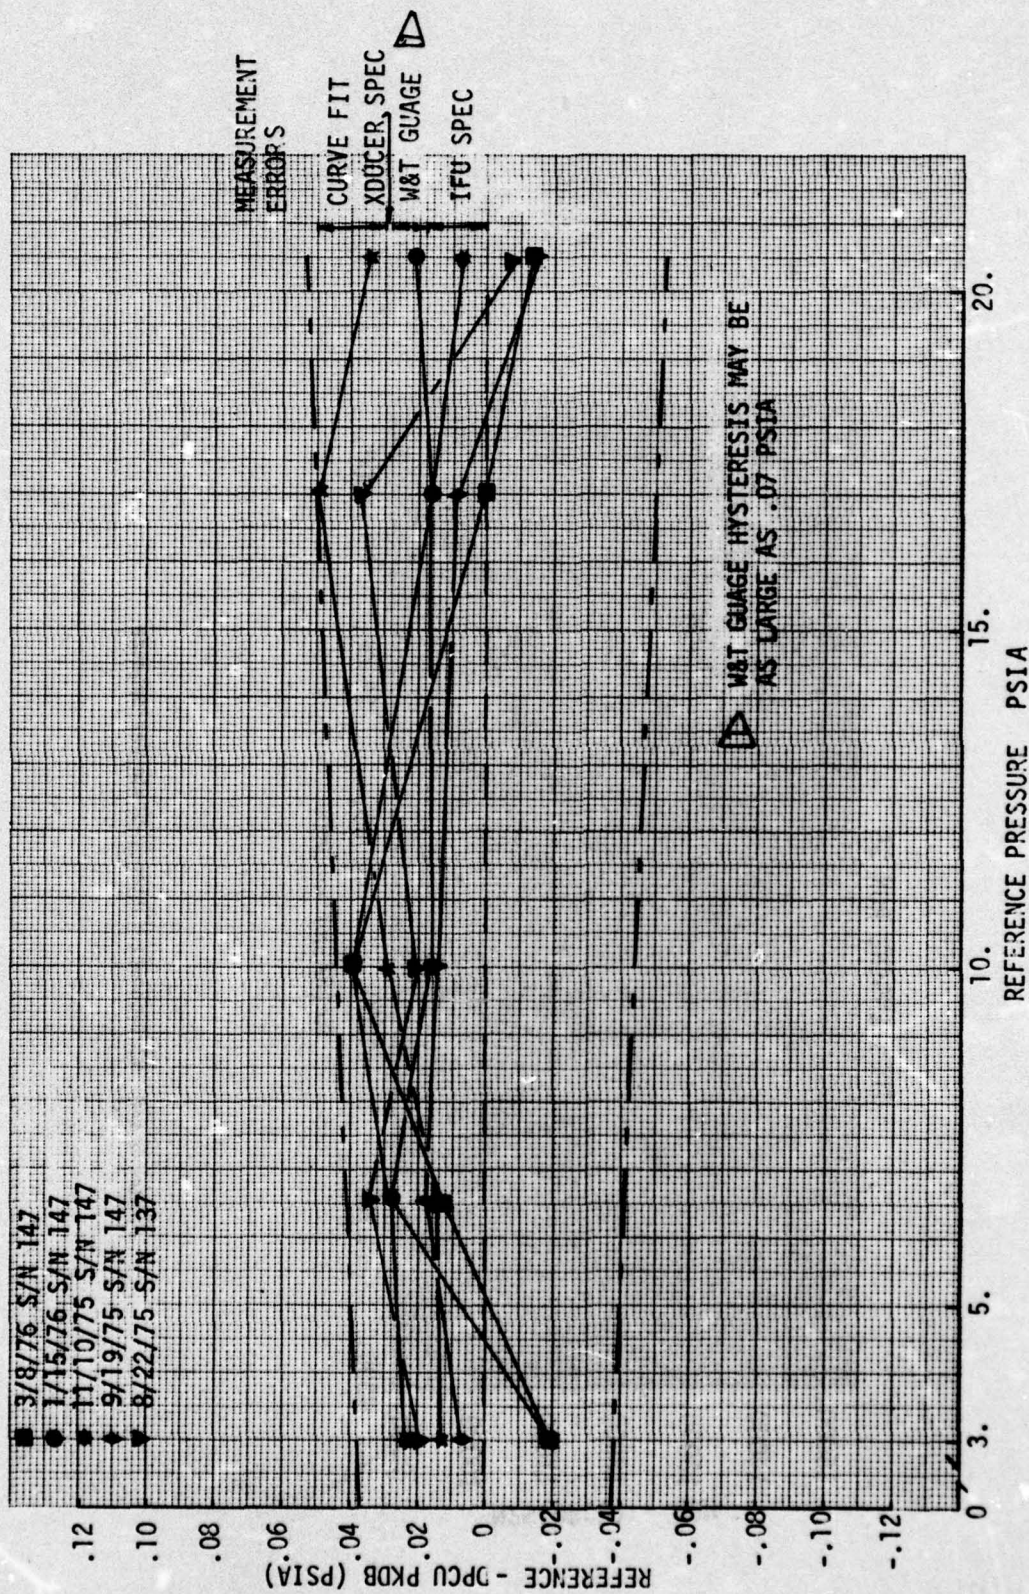
Figure 5.6-9 Paroscientific Transducer Calibrations

After resolution of installation related malfunctions, see section 7.4, the Paros scientific model 230A transducers performed well. A functional check, in the form of a 6 point calibration, was performed per the requirements of Reference 1. A typical set of calibration data are shown in Figure 5.6-9. It is important to emphasize that the errors shown in this figure are not representative of the model 230A accuracy, rather, as indicated on the figure, they represent the error buildup of the IFU and the Wallace & Tiernan gauge used to perform the calibration. This assertion is substantiated by Figure 5.6-10 in which the calibrations of three model 230A transducers before delivery and after completion of the flight test program are compared. These data were obtained from calibrations performed on a Texas Instruments Model 145 pressure reference. Serial numbers 142 and 145 exhibit good null stability, .032% is allowable for two years of service. The apparent span (gain) shift is not within specification. However, the

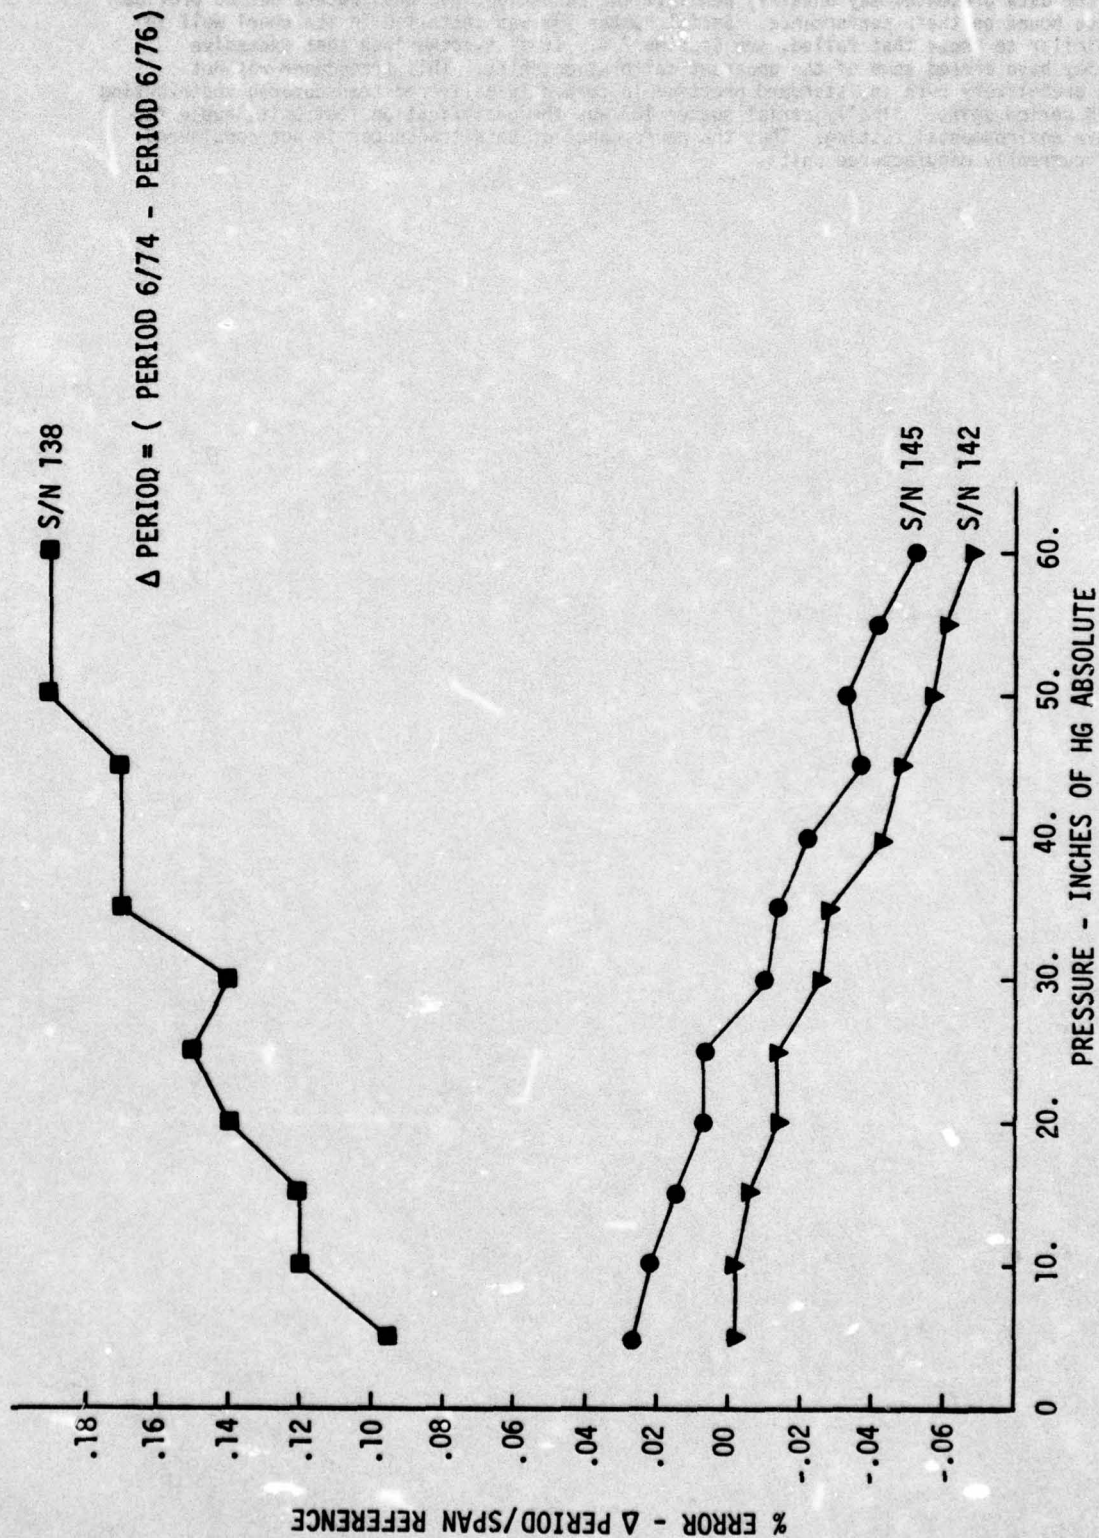
Figure 5.6-10 Paroscientific Transducer Long Term Stability

parallelism of the two curves leads one to question the stability of the TI reference over the two year period. Lacking a June 1974 calibration of the Paroscientific transducers on a primary standard, the data presented may unfairly penalize the Paroscientific transducers but do provide a worst case bound on their performance. Serial number 138 was installed in the wheel well in a manner similar to those that failed, see Section 7.4. It is hypothesized that excessive vibration may have caused some of the apparent calibration shift. This transducer was not subject to predelivery burn in, standard practice in currently delivered transducers, contributing perhaps .1% period shift. Finally serial number 138 was the qualification test unit, subjected to extensive environmental testing. Thus the performance of this transducer is not considered typical of currently manufactured units.

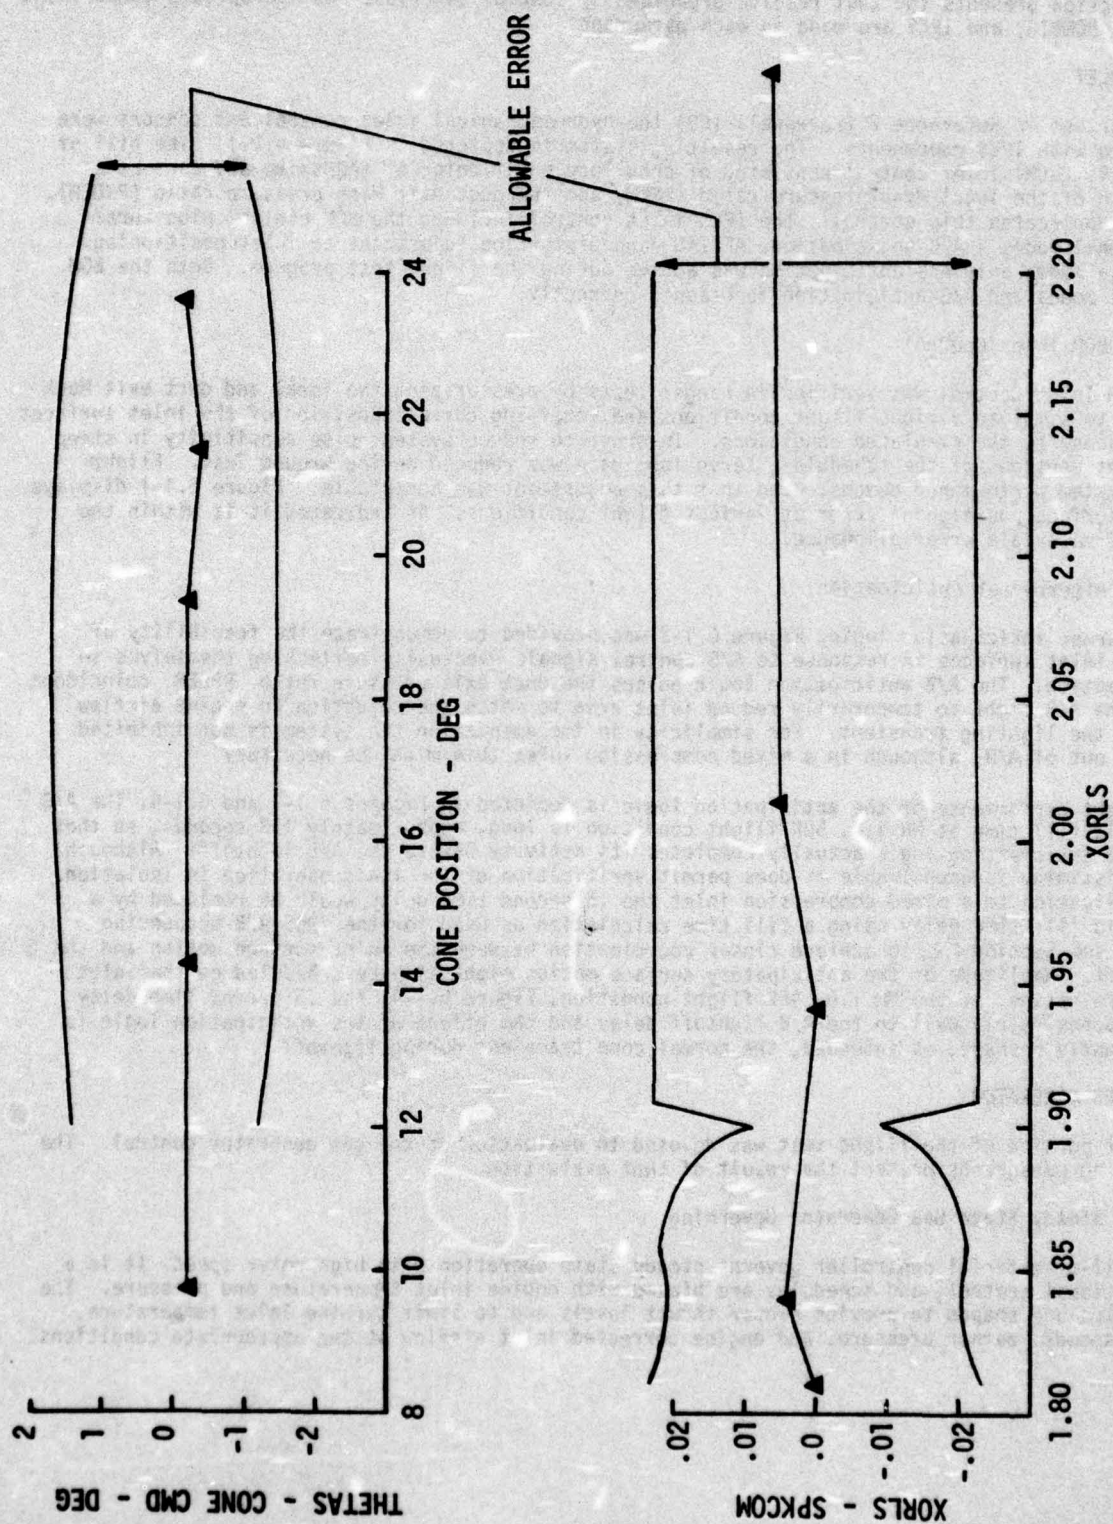
Figure 6.1-1 Inlet System Positioning Error

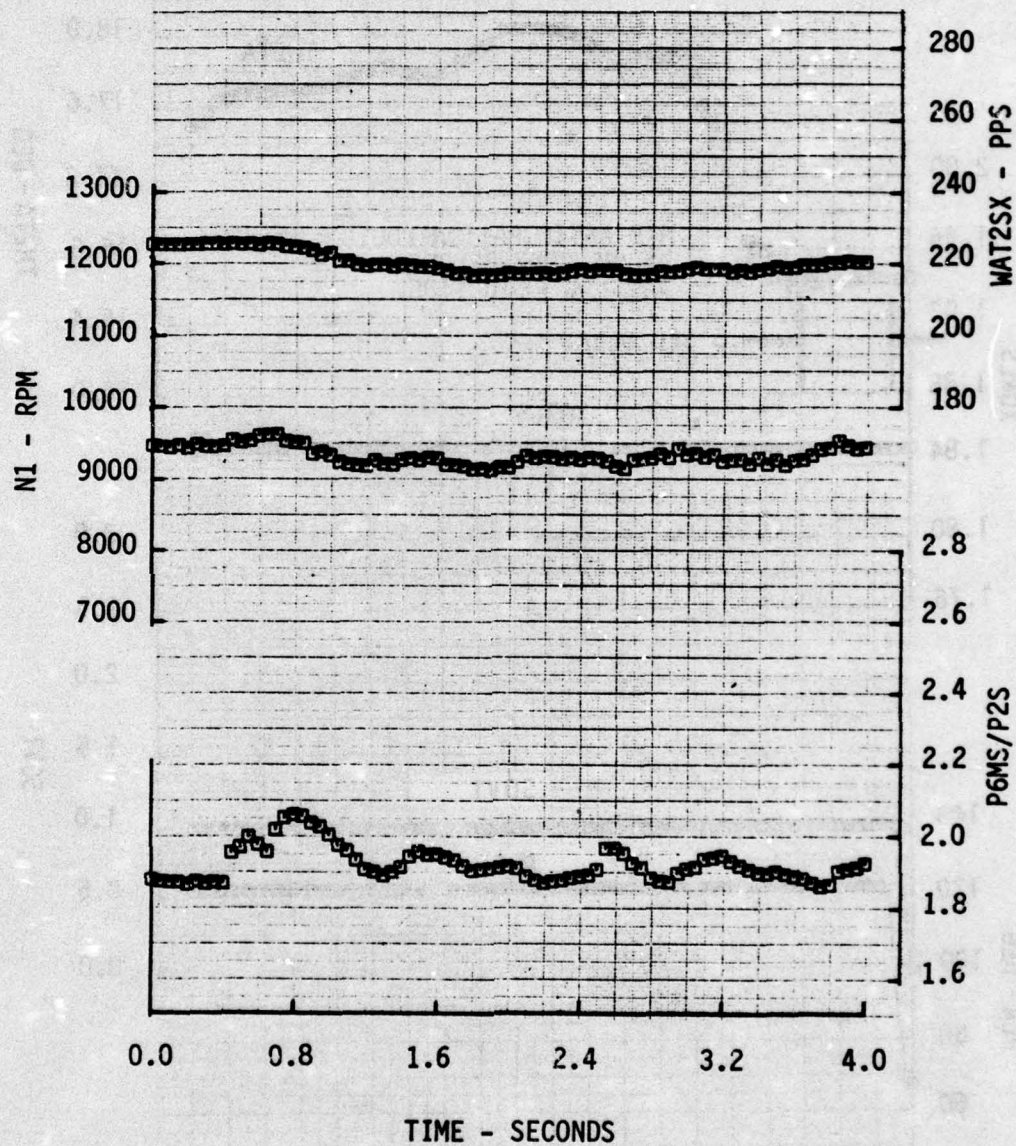
Figure 6.1-4b A/B Anticipation at Mach 1.6

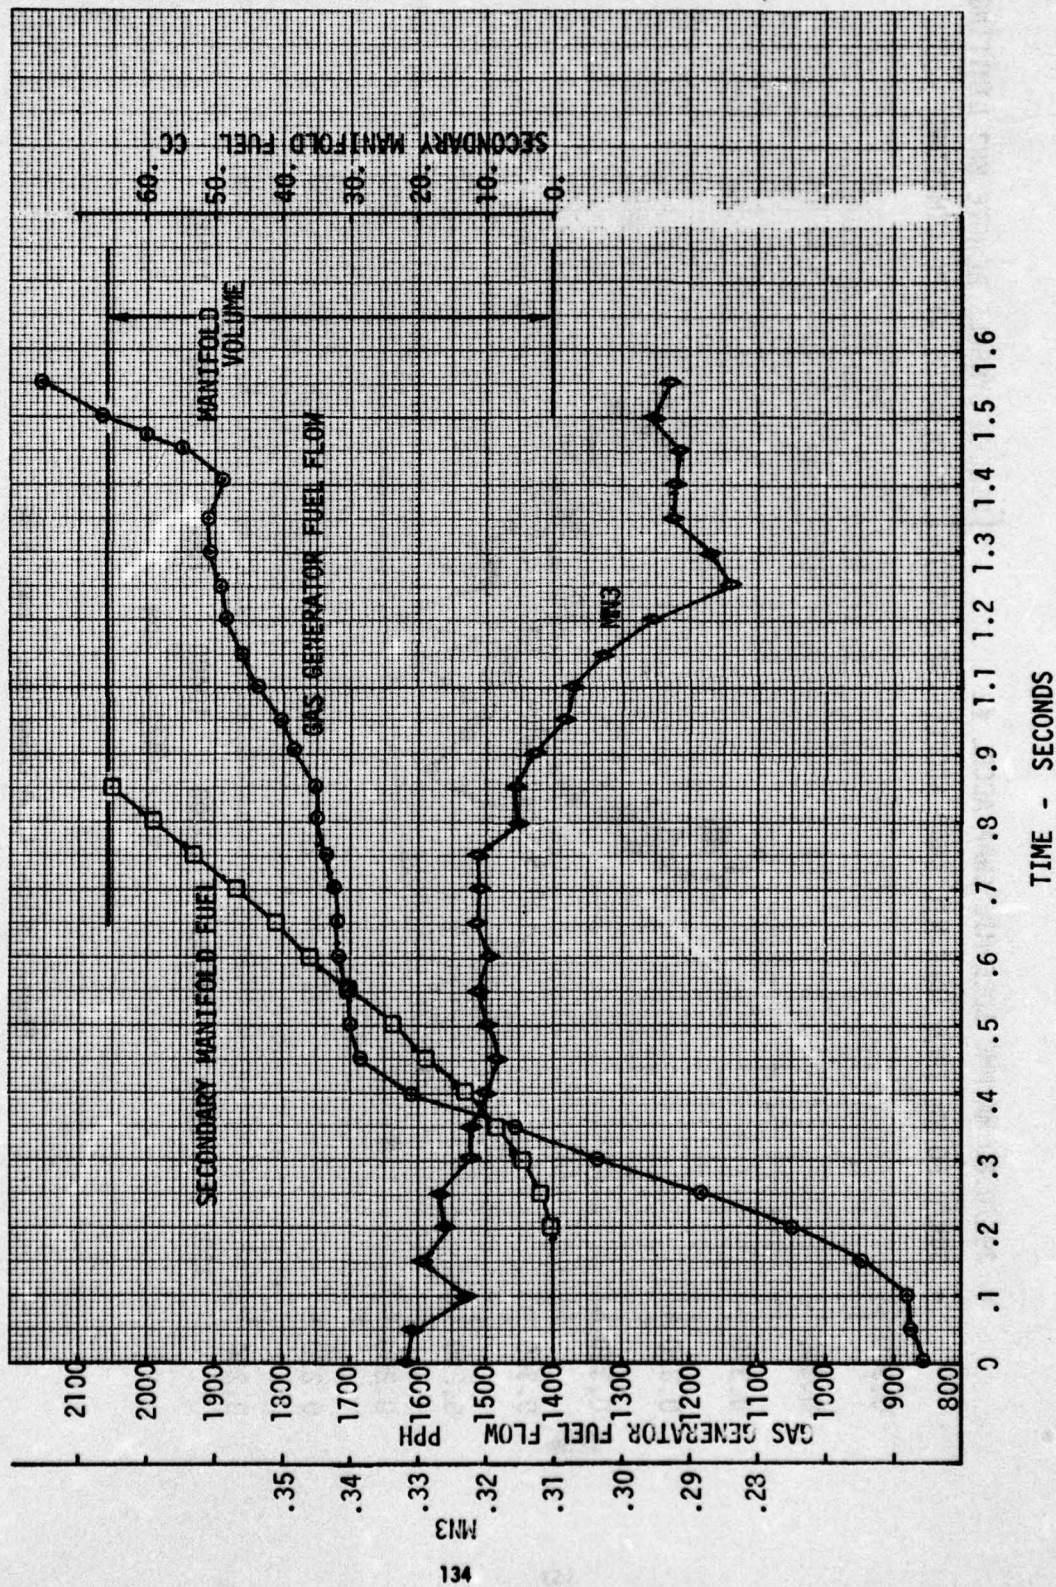
Figure 6.2-10b Accel Comparison - 30K,.8Mn

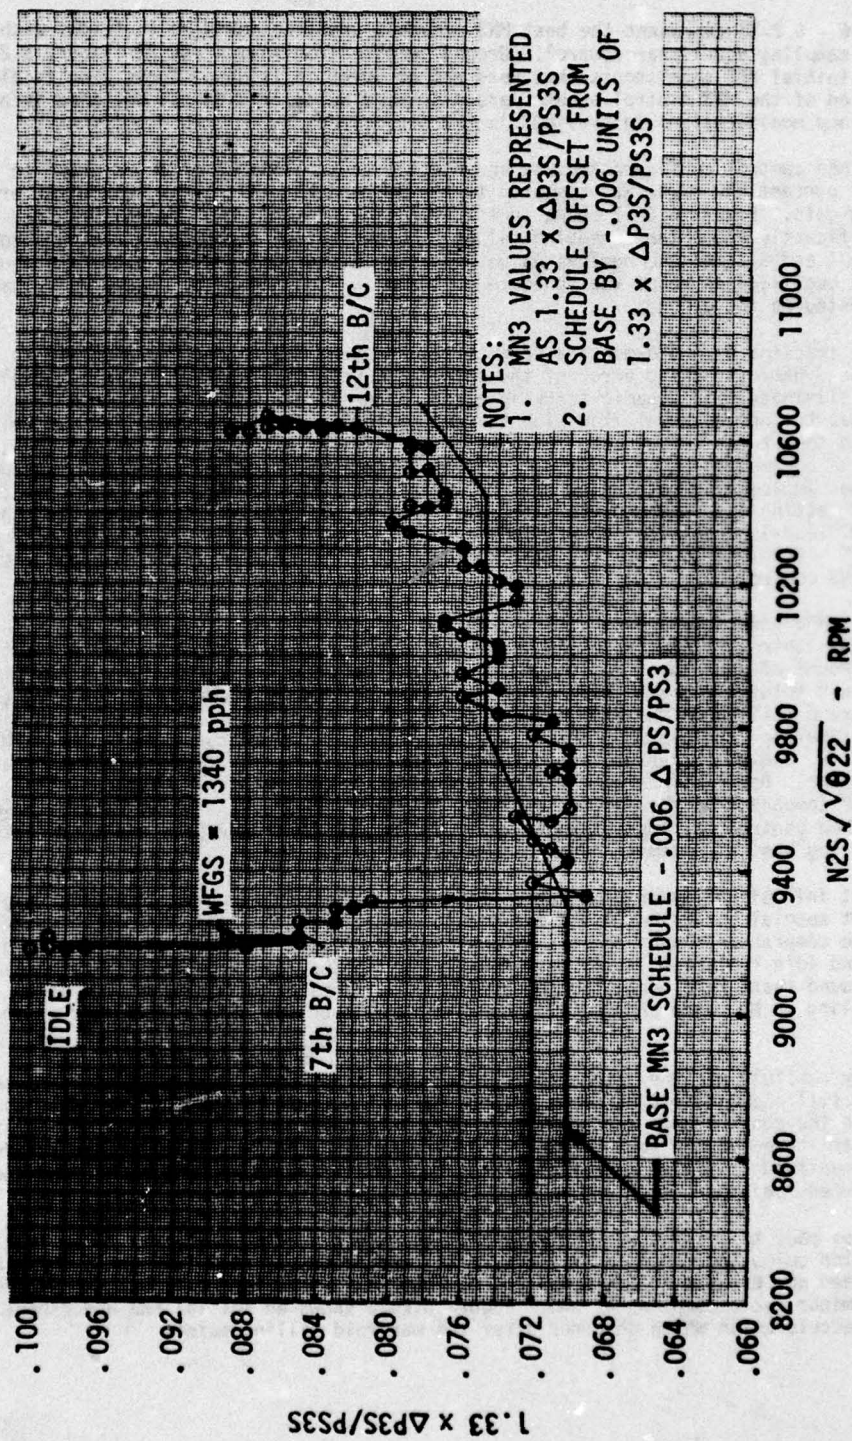
Figure 6.2-16 Idle-M11 MN3 IPCS

Figures 6.2-6 - 6.2-13 represent the best MN3 schedule tracking achieved in flight with the major cycle sampling non-linear control. Ground testing from engine run 25 (Figure 6.2-6) showed some initial MN3 undershoots that were not observed in flight. These results along with the evaluation of the MN3 control schemes are discussed below. Additional detailed information on the MN3 loop modifications is provided in Section 8.1.2.

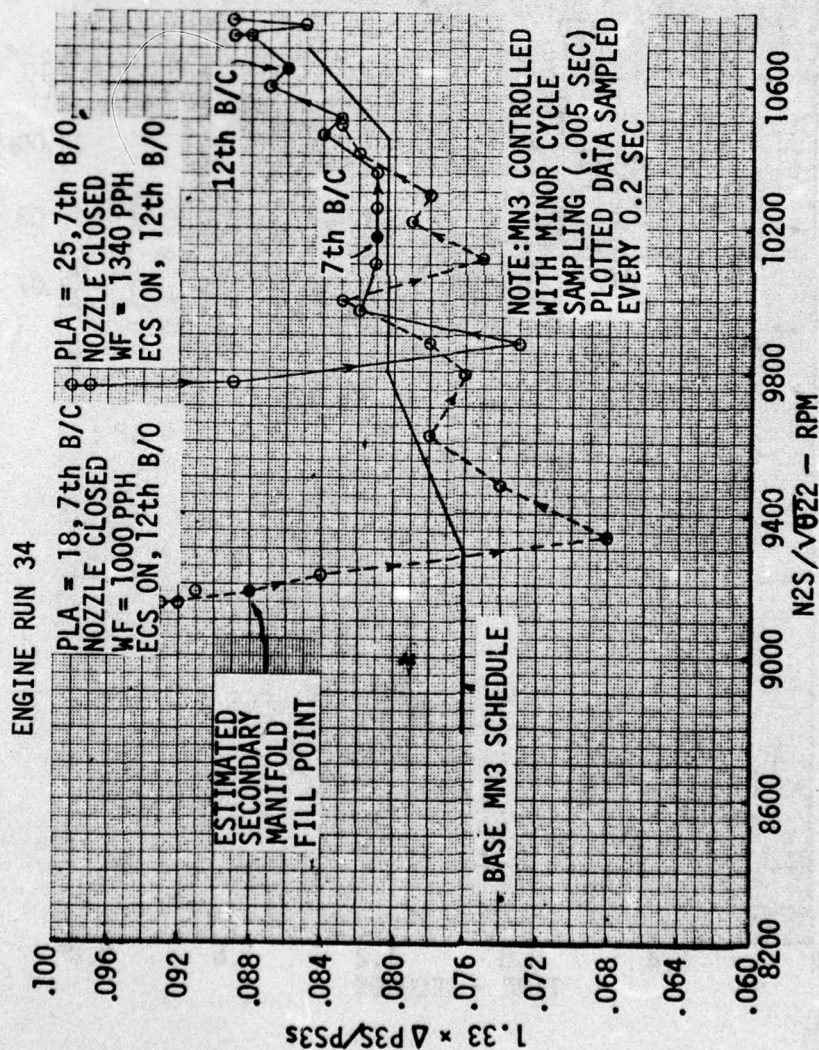
Figure 6.2-20 Effect of 7th Stage Bleed and Secondary Manifold on MN3 Undershoots

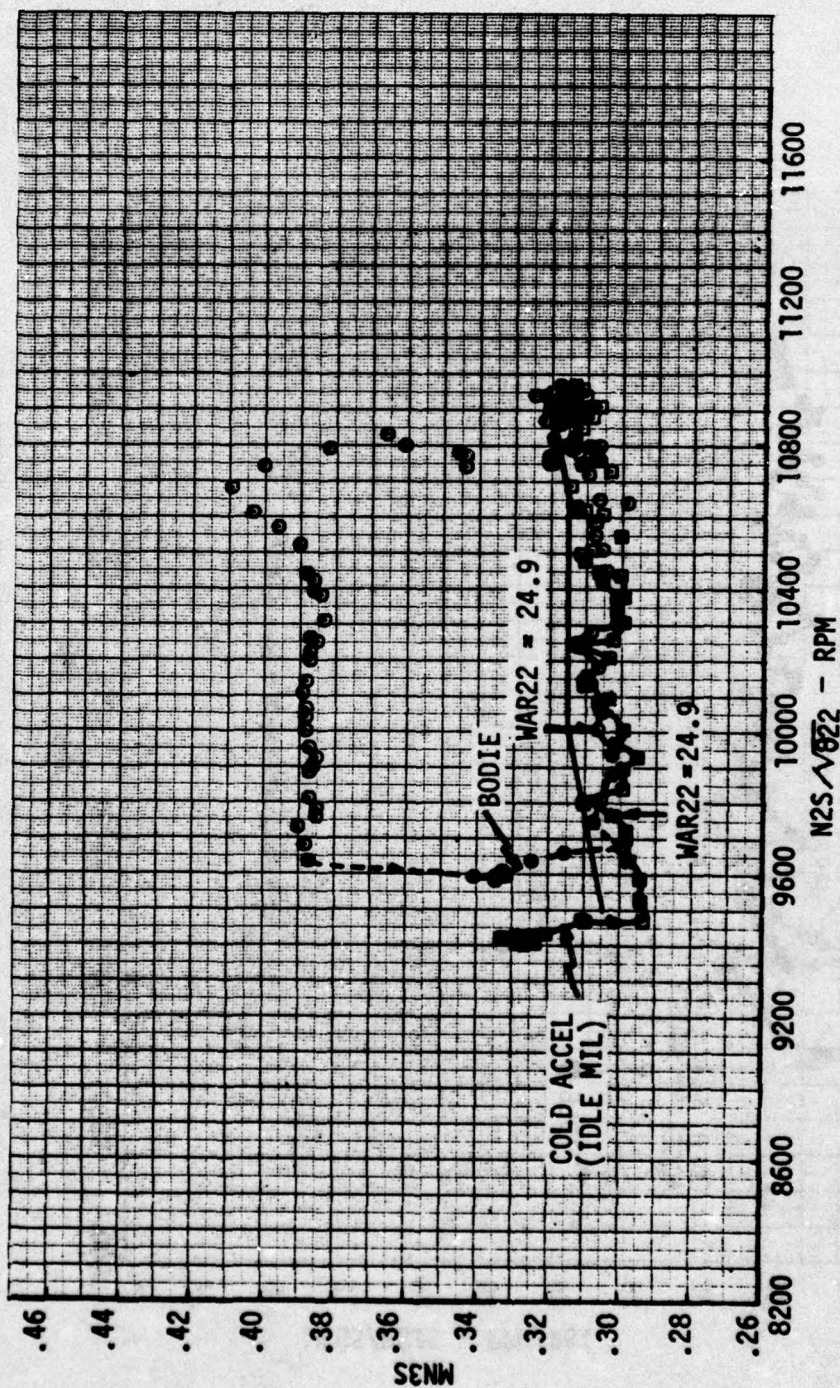
Figure 6.2-27 MN3 During IPCS Bodie

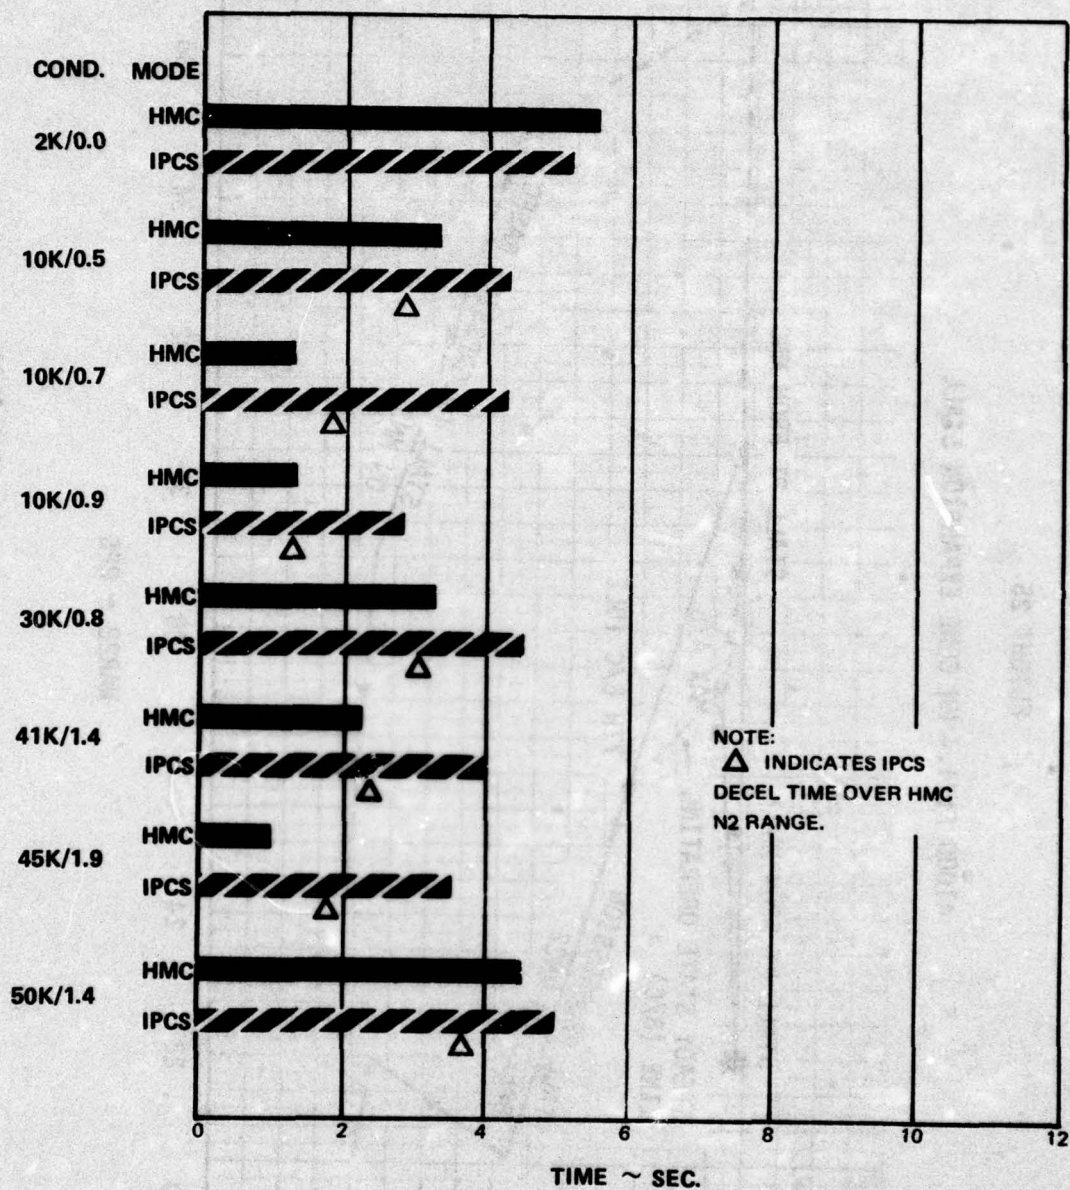
Figure 6.2-37 Decel Time Comparison M11-Idle

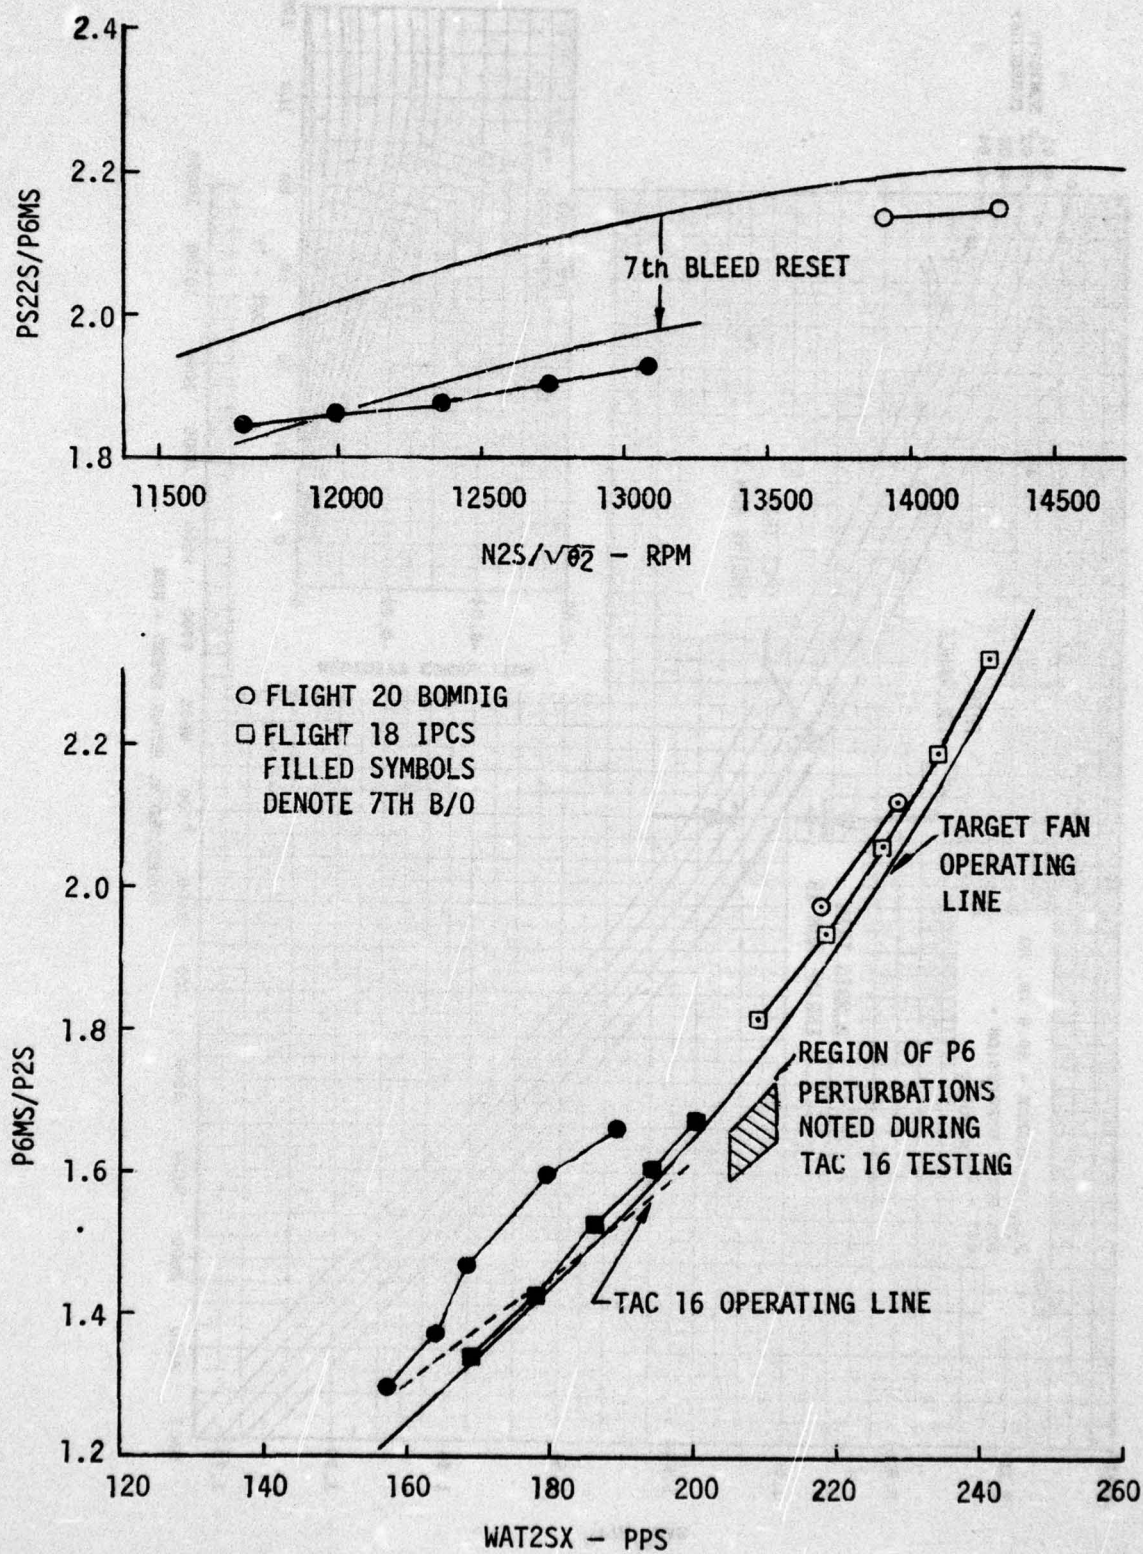
Figure 6.3-1 Suppression Control Comparison IPCS Vs BOMDIG

The pilots reported "A/B roughness" during several of the IPCS 650 kt. accelerations. This roughness was characterized by 4 percent  $P6MS/P2S$  oscillations at 2-3 hz. It was also observed during the TAC 16 development testing (Figure 6.3-1) and was caused by a marginal unsuppression. In an effort to eliminate this reported roughness during the IPCS flights, the target fan operating line was increased in the region where the oscillations were observed as seen in Figure 6.3-3. The first revision eliminated the roughness, as indicated by the table summary in Figure 6.3-3, but since A/B stalls were also encountered during this flight, a second revision was made. The second revision resulted in a reoccurrence of the roughness, so a third and final change was made which resulted in neither pilot reporting roughness or A/B stalls.

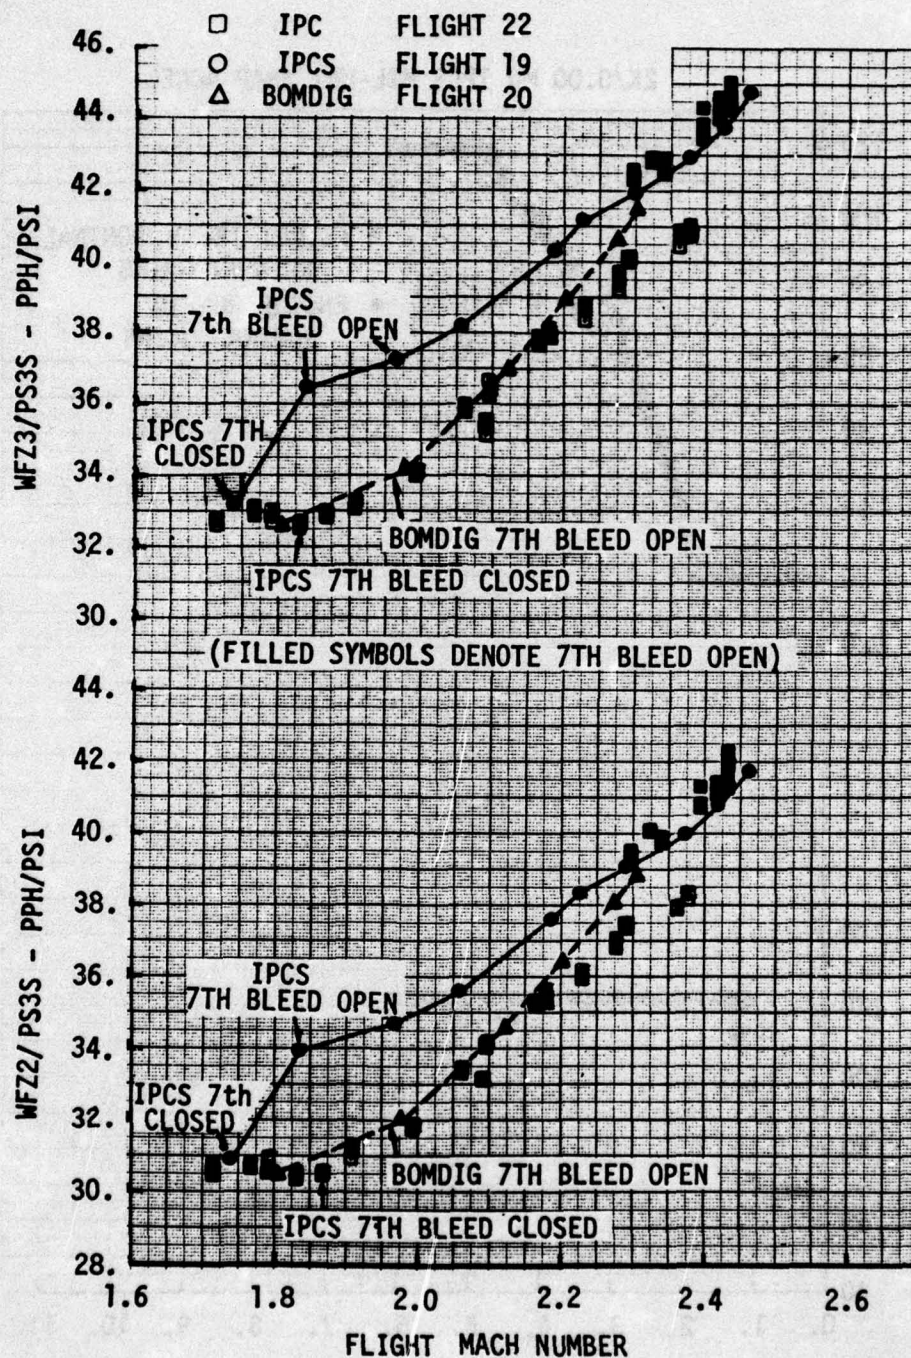
Figure 6.3-4 A/B Fuel Flow Scheduling - BOMDIG, IPCS

Oscillations in A/B fuel flow and nozzle area were observed during the ground tests. A review of altitude test data showed that fuel oscillations existed at max afterburning. Engine running identified the cause of the oscillations as  $N_1$  noise and showed that reducing the trim loop gains was effective in reducing the sensitivity to the noise (paragraph 5.6). As a result the proportional and integral gains were reduced 6 dB. Following flight 17 a six sample block average filter was used on the  $N_1$  signal to further reduce the noise. The secondary advantage of the reduced gains was elimination of the  $A_j$  overshoot during snap accels. Figure 6.3-5 shows an early engine run (10) snap from MIL to MAX with an area overshoot midway up during the accel. The reduced gains resulted in a flat in the area transition at the same point during a later run.

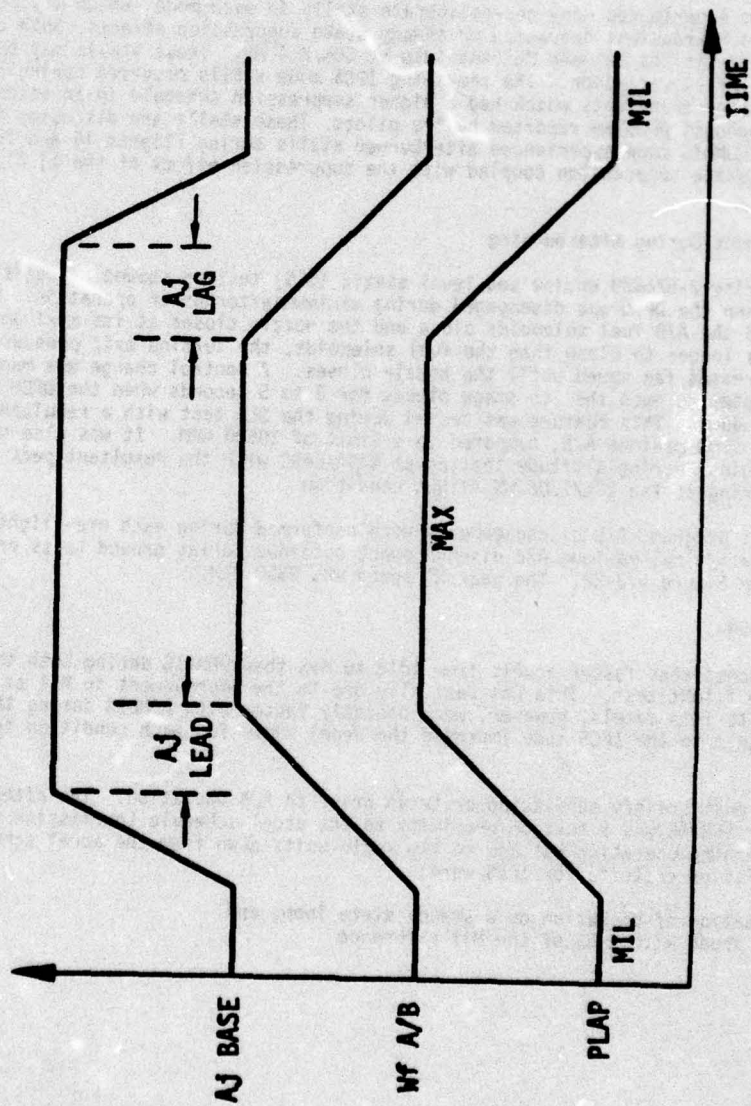
Figure 6.3-19 IPCS Base Area Schedule

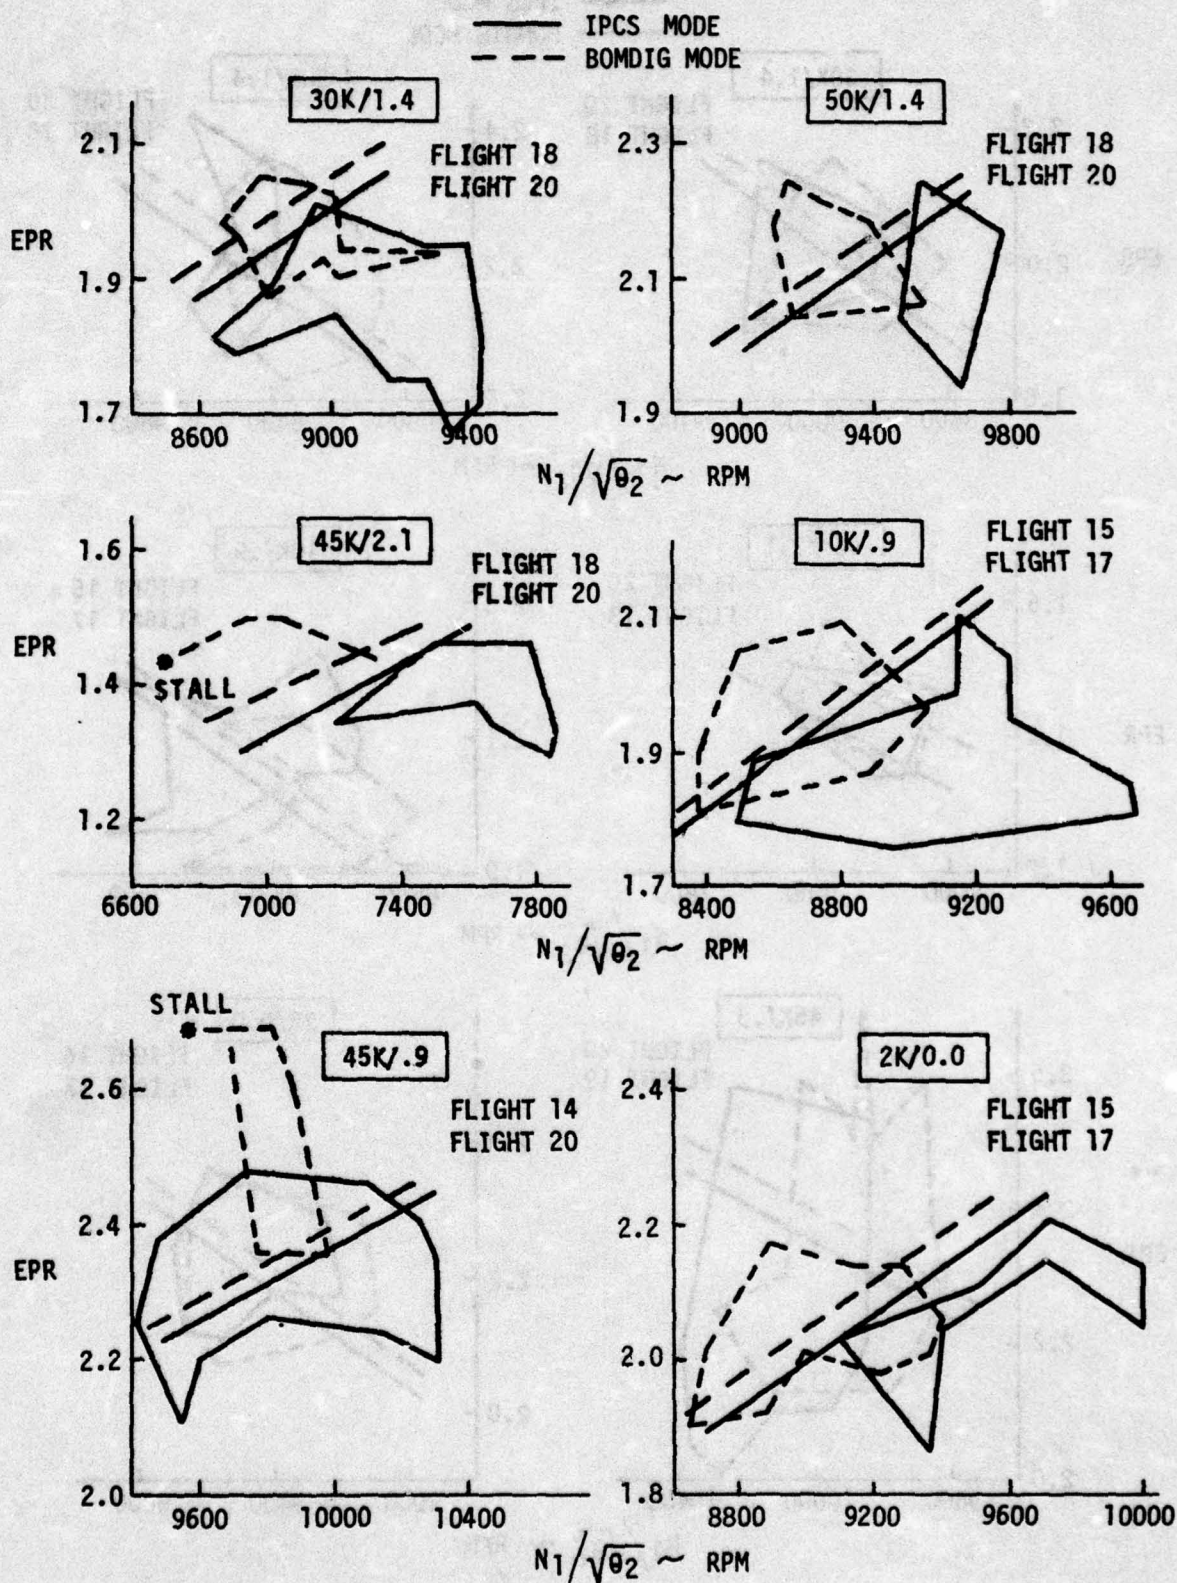
Figure 6.3-21 Fan Suppression Comparison During Max to M11

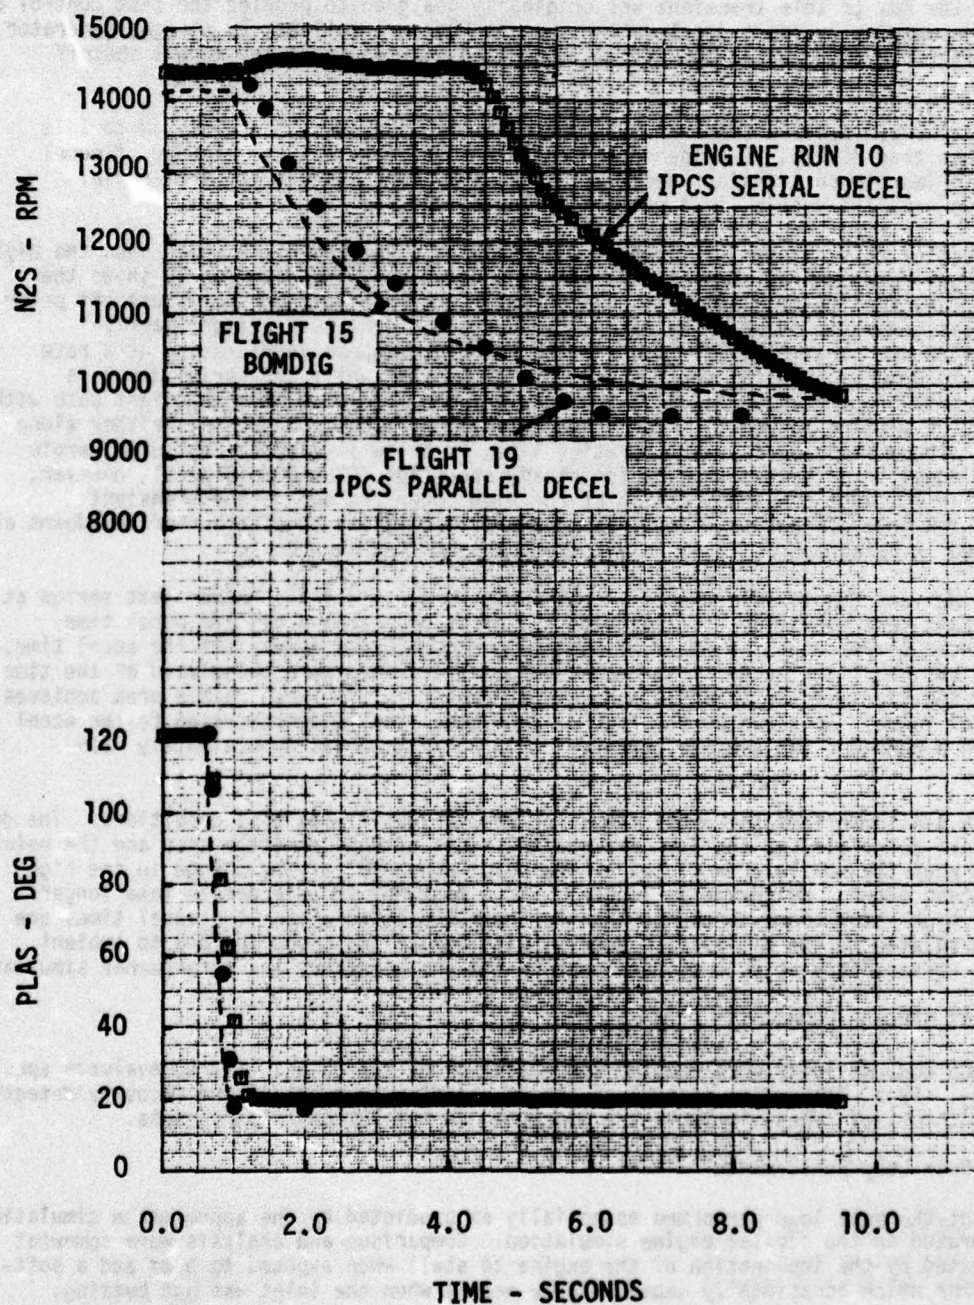
Figure 6.4-1 Speed Comparison for Serial and Parallel Max-Idle Decel
